**Fairlington Mews Condominium Association
Arlington, Virginia**

EXECUTIVE SUMMARY

At the direction of the Board that recognizes the need for proper reserve planning, we have conducted a *Precision 20/20 Full Reserve Study* of Fairlington Mews Condominium Association (Fairlington Mews) located in Arlington, Virginia and submit our findings in this report. The effective date of this study is the date of our visual, noninvasive inspection, December 14, 2009. We conducted previous Reserve Studies on March 21, 2006 and July 23, 2007. This Reserve Study is a budget planning tool that identifies the current status of the reserve fund and a stable and equitable Reserve Funding Plan to offset the anticipated future major common area expenditures.

Fairlington Mews Condominium Association is a townhome style development of 277 units in 43 buildings. The exteriors of the buildings comprise brick masonry and wood trim with slate roofs. The buildings were built in 1943 and converted to condominiums in 1978. Fairlington Mews is a Virginia Historic Landmark and on the National Register of Historic Places. The development contains asphalt pavement parking areas, a pool and tennis courts. We ide

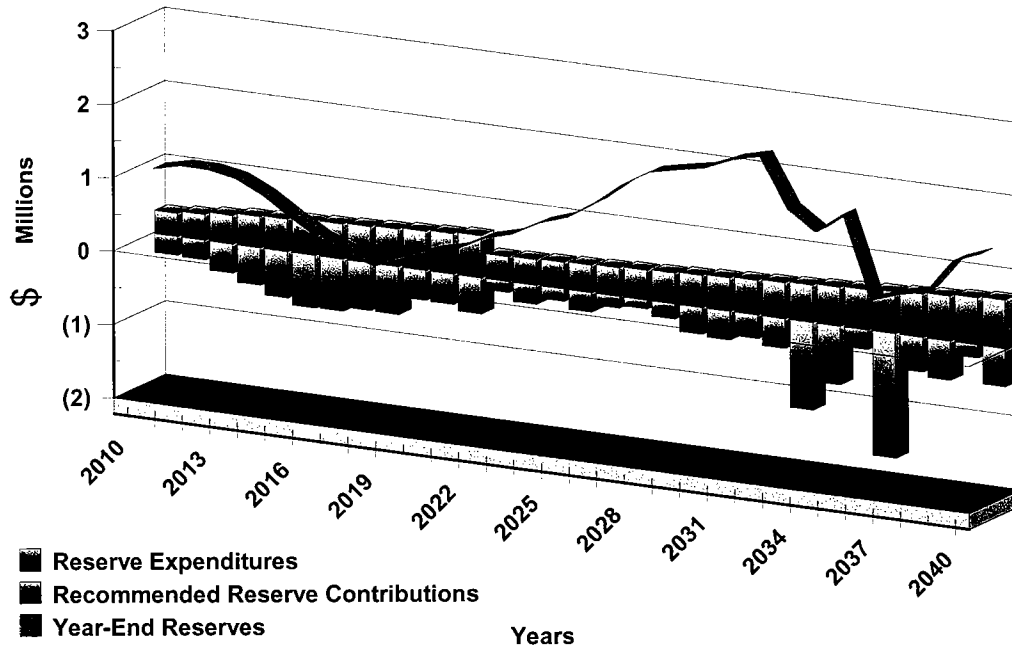
Recommended Reserve Funding Plan Fairlington Mews Condominium Association

Based on the investigation and analysis as detailed in the accompanying narrative, we recommend the following Reserve Funding Plan (Reserve Contributions) to offset the anticipated future Reserve Expenditures of the subject Reserve Components during the next 30 years.

Recommended Reserve Contributions

Year	\$	Year	\$	Year	\$
2011	355,100	2021	578,200	2031	475,600
2012	392,100	2022	340,000	2032	493,700
2013	429,100	2023	352,900	2033	512,500
2014	445,400	2024	366,300	2034	532,000
2015	462,300	2025	380,200	2035	552,200
2016	479,900	2026	394,600	2036	573,200
2017	498,100	2027	409,600	2037	595,000
2018	517,000	2028	425,200	2038	617,600
2019	536,600	2029	441,400	2039	641,100
2020	557,000	2030	458,200	2040	665,500

The Association budgeted \$318,090 for Reserve Contributions in 2010¹. We recommend that the Association adopt a reserve budget of \$355,100 in 2011, \$392,100 in 2012 and \$429,100 in 2013. Afterwards, the Association should budget gradual annual increases in reserve funding, that in part consider the effects of inflation through 2021. By 2022, the Association will have fully funded for slate roof replacements and may anticipate a *decrease* in Reserve Contributions to \$340,000. Afterwards, the Association should again budget gradual annual increases in reserve funding, that in part consider the effects of inflation through 2040, the limit of this study's Cash Flow Analysis.

for the major expenditures as identified in **Exhibit B. Exhibit B Reserve Funding Plan** enumerates the details regarding recommended annual Reserve Contributions and projected year end reserve balances.
